PASSAIC RIVER BASIN
MOLLY ANN BROOK,
PASSAIC COUNTY
NEW JERSEY

OLDHAM POND DAM

NJ 00238

PHASE 1 INSPECTION REPORT NATIONAL DAM SAFETY PROGRAM

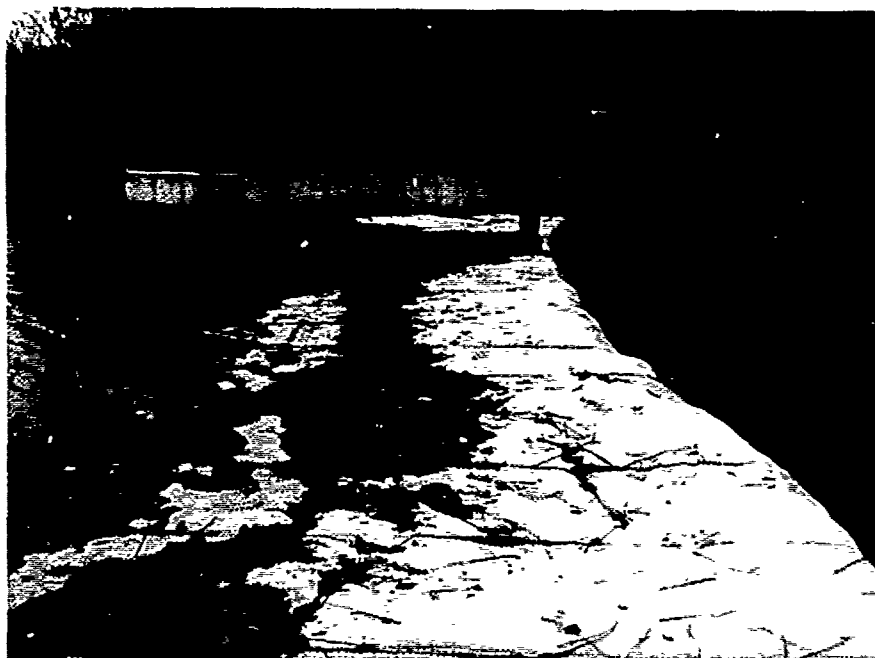
7 NOVEMBER 1979
VIEW FROM WEST TRAINING WALL OF CENTER EMERGENCY
SPILLWAY SHOWING "FABRIFORM" CONCRETE MATTRESS
SPILLWAY CREST AND RECENTLY REBUILT TRAINING WALL.
VIEW IS LOOKING EAST.
